Shore Friendly Mason | Mini-Grant Program

Drainage Improvement Projects

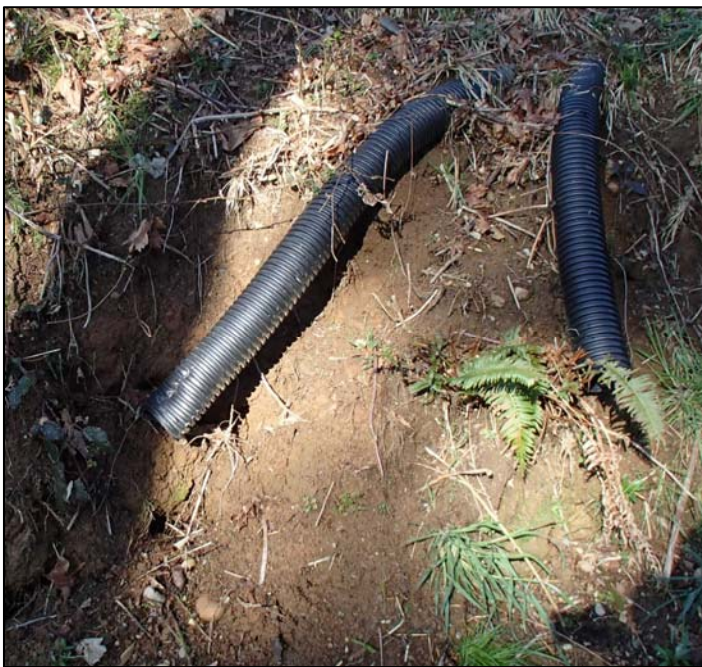
Above: a problematic drainage pipe that releases water on the face of a slope rather than at the base. The water does not slow down as it leaves the pipes, which results in scouring and bare soil. The slope is beginning to erode and will only get worse without improvements.

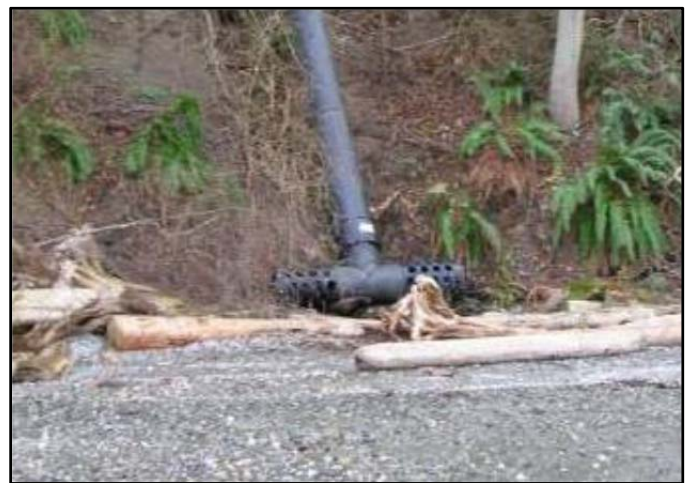
Above: a pipe with a “diffuser tee” that outlets water near the base of a slope. The diffuser is attached to the end of the pipe to slow the water down and decrease its energy as it exits, thus preventing beach erosion.

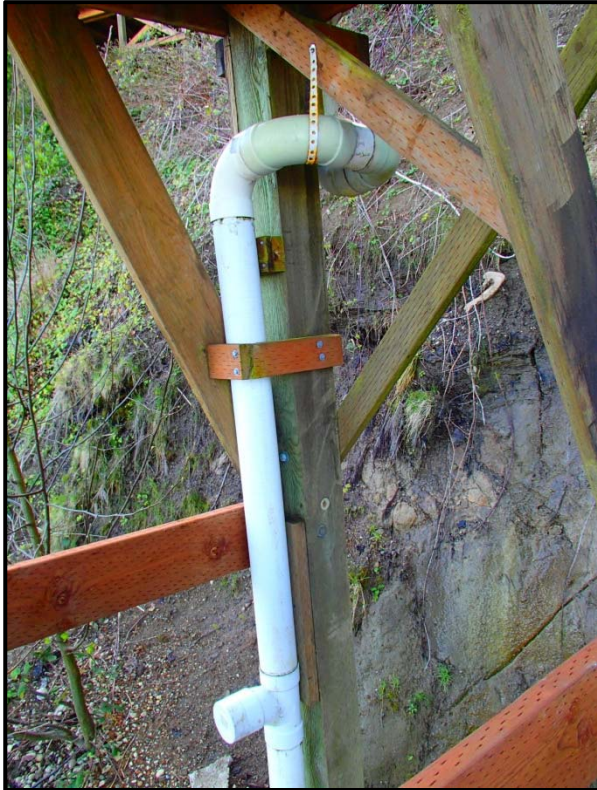
Above: a well-secured, solid drain pipe carries water down the face of a bluff to a safe outlet near the base of the slope. A system like this is easy to clean and monitor for leaks.

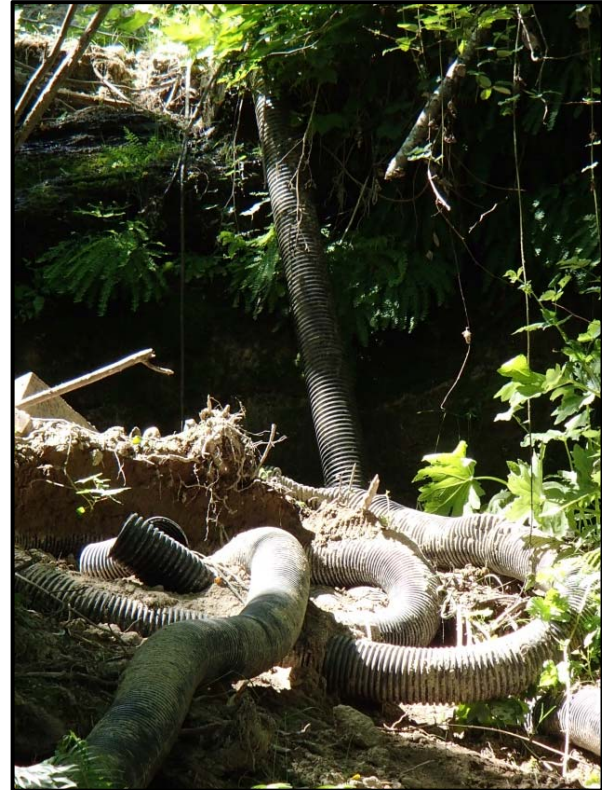
Above: an example of a failed drainage system associated with a landslide. Poorly-secured pipe connections, undersized drainage pipes, or leaks in conveyance pipes can compromise the integrity of drainage systems. Good design and regular monitoring can help identify issues and prevent failures.
